# Performance Benefits of Fiber-Reinforced Thin Concrete Pavement and Overlays

*A pooled fund project administered by the  
Minnesota Department of Transportation*

Report No. NRRA202106

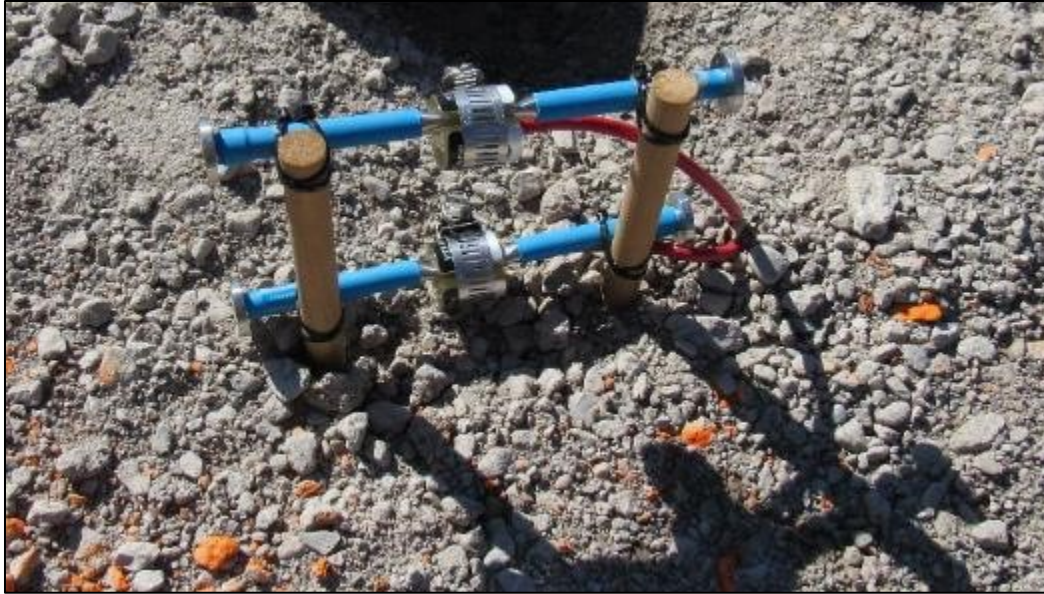
Vibrating wire (VW) sensors were installed in all the cells to measure the strains caused by responses to environmental-based changes within the slabs. A photograph of a vibrating sensor is shown in Figure 2-6. The raw data from this type of sensor is converted to estimate the environmental strain exerted on the concrete due to the change in the moisture state, temperature and temperature gradient, freezing of underlying layers, and joint locking. Data was collected from VW sensors every 15 minutes.

Figure 2-6. Photograph of a vibrating wire (VW) sensor.

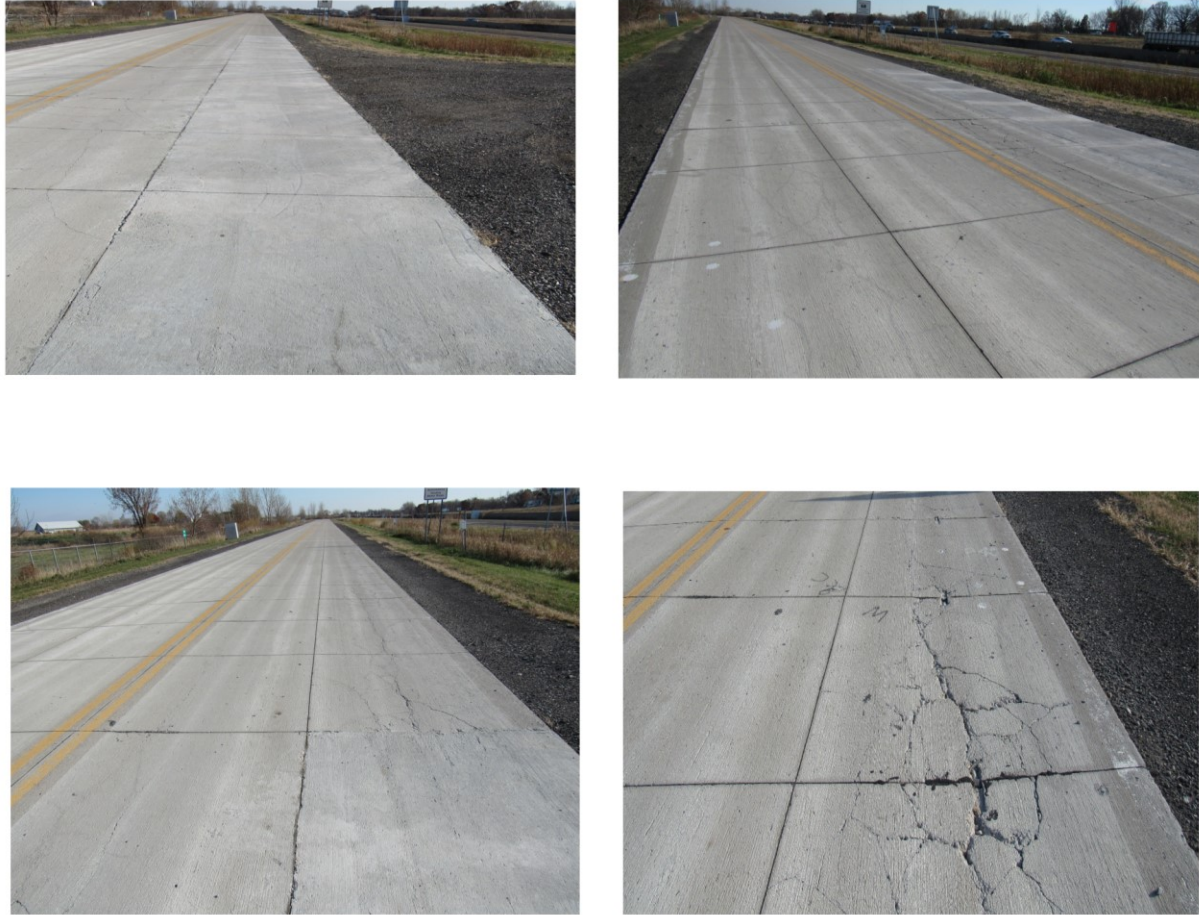
On the other hand, unrepaired (original) slabs continued to develop distress with traffic load and age, with primary longitudinal and secondary transverse and diagonal cracks. Based on the December 2019 distress survey data, it was found that as much as 75% of the slabs had cracked in Cell 139 after 114,000 ESALs were applied to them. Figure 3-4 shows four photographs of Cell 139 taken in October 2019. The unrepaired slabs eventually failed and became undrivable in the middle of the third year of service (2020).

**Figure 3-4. A few photographs of Cell 139 during October 2019.**

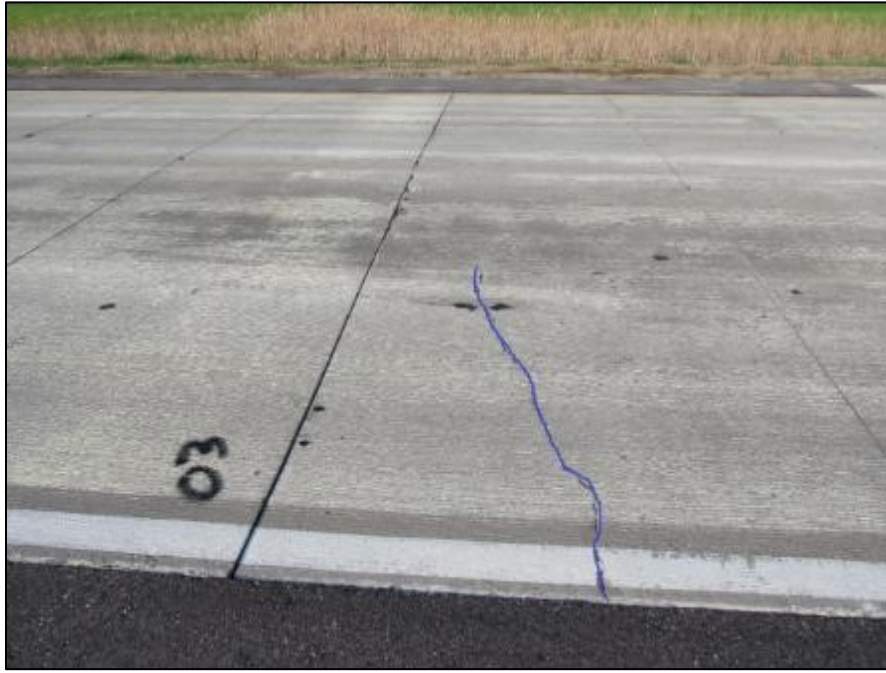
**Figure 3-8. Transverse crack in Cell 506 (control, non-FRC) observed in the year 2018.**

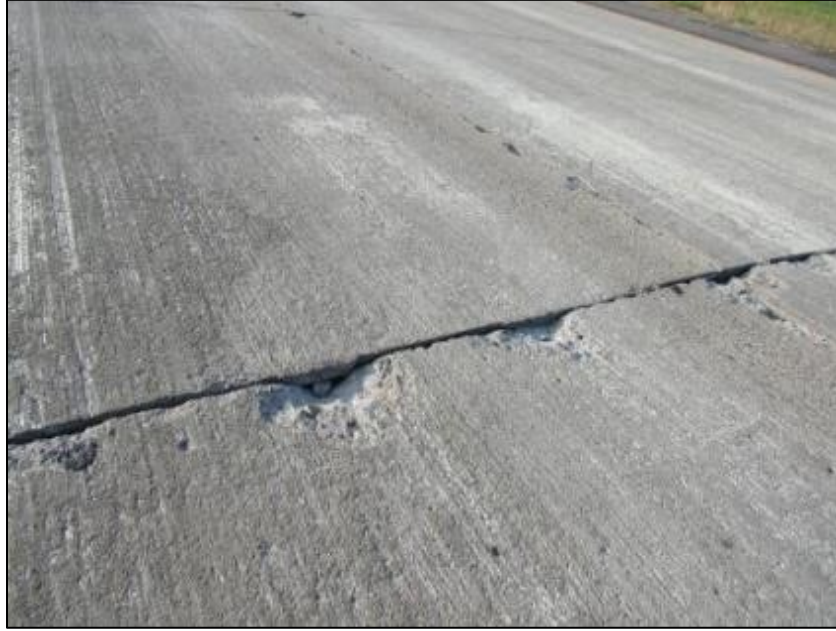
Figure 3-9. Spalling in Cell 506 (control, non-FRC) observed in the year 2018.

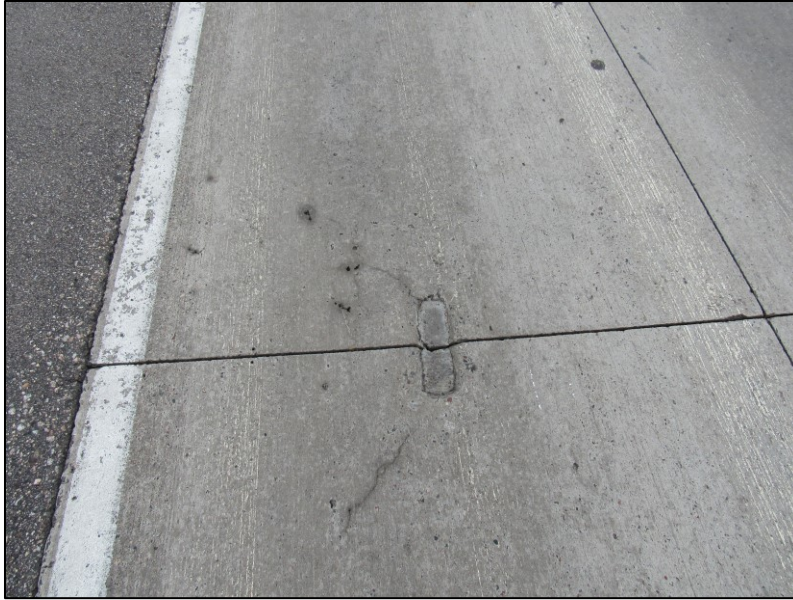
**Cells 706 and 806**, which were constructed with fiber dosages of 8 and 11.7 lbs./cy, respectively, did not experience any cracks or spalling before October 2019 except for a couple of narrow cracks in Cell 806 originating at the location of a joint opening sensor (Figure 3-15). The March 2020 distress survey did not report any additional cracks for these two cells.

**Figure 3-15. Narrow cracks in Cell 806, originated at the location of the joint opening sensor.**

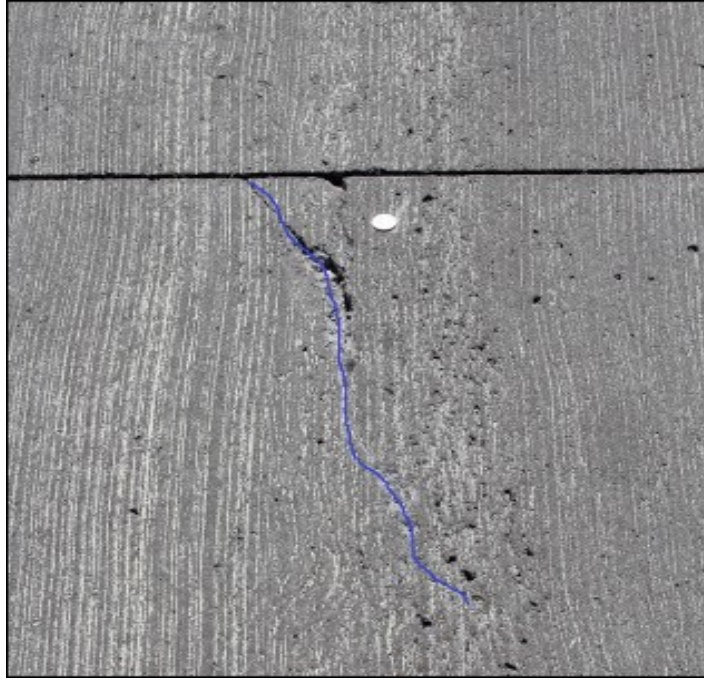
Figure 3-22. Longitudinal crack in Cell 805 (2018)

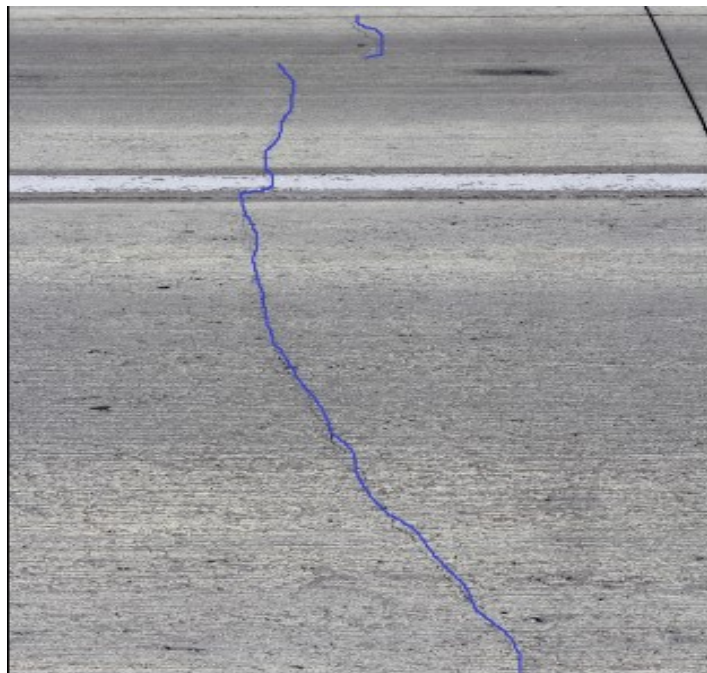
Figure 3-23. Transverse crack in Cell 805 (2018)

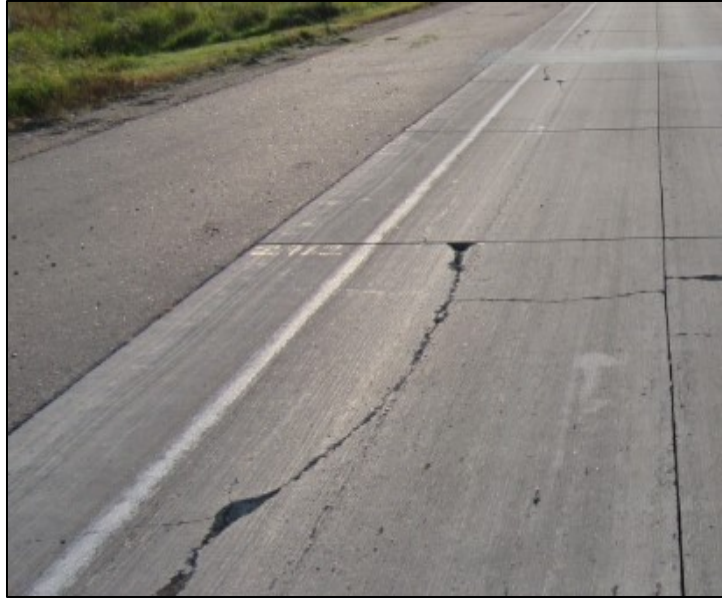
Figure 3-26. Photograph of Cell 805 before removal on September 2020.

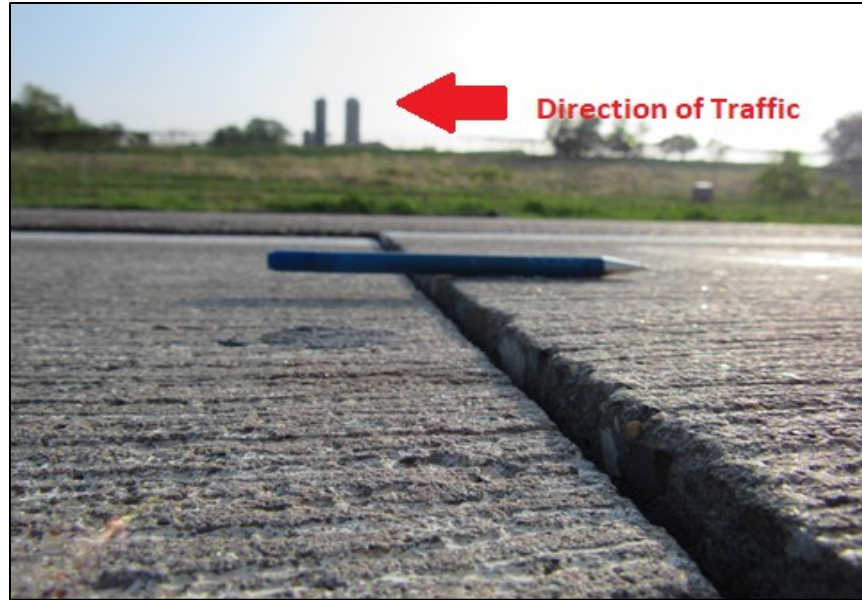
Figure 4-3. Photograph of faulting of Cell 506 (non-FRC). Note that the faulting shown in this photograph is exaggerated due to the broken corner in the slab on the leave slab.
